Manhole Inspection Summary

Manhole # S27M__021MH

Insp Date: **5/5/08 2:40 PM**

Location Address: **1119 Naticoke St**

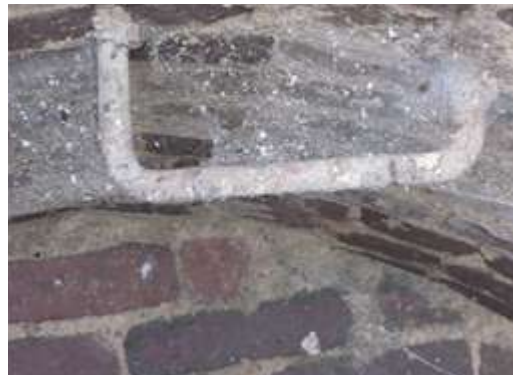
Defect 1

Count: **1** Missing: **0** ☒ **Corroded**

corroded steps

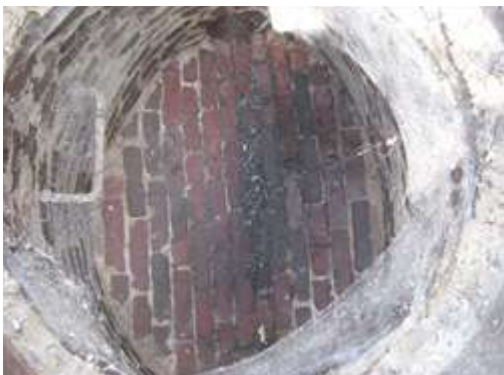
Defect 2

Offset: **1.5** (in.)

Frame Offset 1.5"
